ARMY AVIATION SAFETY

- CRASH INJURY
- CRASHWORTHINESS

Final Report
U. S. ARMY
TRECUM Contract
DA 44 177 TC 624
TREC Technical Report
60 77
AvCIR 70 0 128
30 December 1960

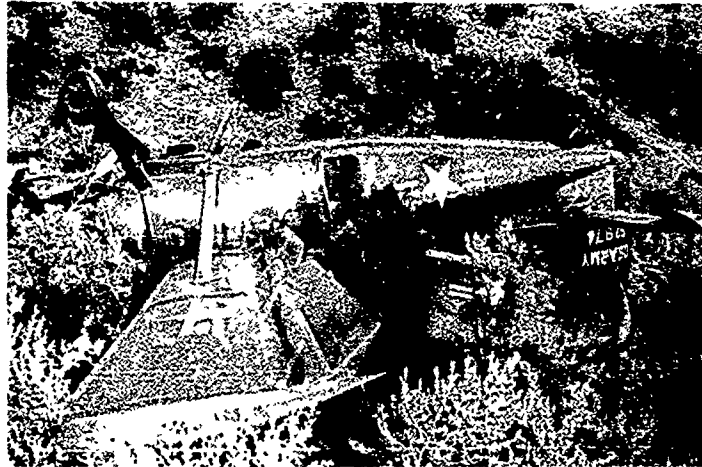
During this descent, the left horizontal stabilizer struck the trunk of a dead tree. The aircraft then struck the side slope of the canyon in extremely rugged terrain impacting on its left wing, nose, and left side

The cockpit and cabin remained reasonably intact. Major damage was sustained by the left wing, the left landing gear, the left lower side of the fuselage, and the engine and nose section. All occupied cabin seats except two were either torn free, broken, or distorted.

The crash injury investigation conducted on 18-20 June 1959 revealed that the injuries experienced were the result of the occupants' being thrown free due to the seat and/or seat belt failures or striking interior structure and rifles. The analysis of the injury causation factors resulted in recommendations for: (1) increased strength of seats and tie-downs; (2) a more suitable restraint system for occupants; and (3) a method of storing hand-carried weapons.

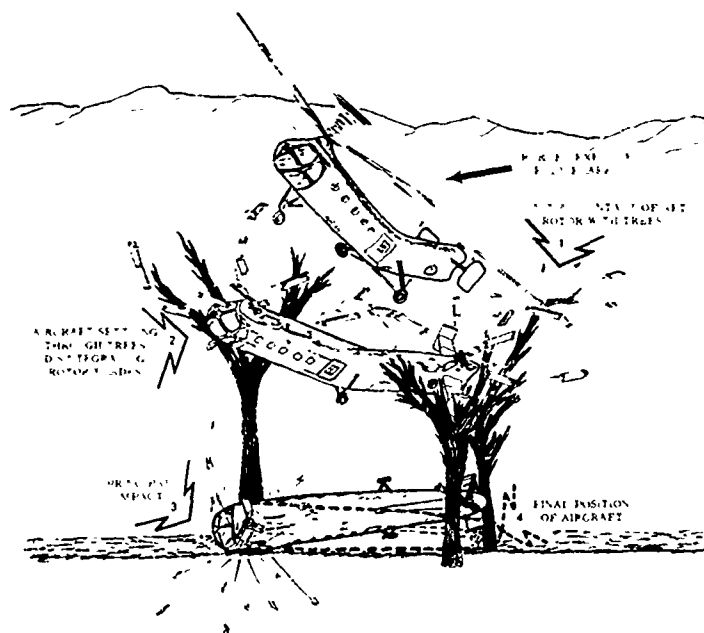
U. S. ARMY H-21C SHAWNEE HELICOPTER ACCIDENT BIG MEADOWS, VIRGINIA 2 DECEMBER 1959

During the crash sequence, the aircraft rolled approximately 90 degrees to the left scraping down the sides of the trees approximately 40 feet in height. The aircraft impacted on its left side. Initial ground contact occurred

revealed that the predominant causes of injuries were failures of seats and seat belts. The investigation found also that relatively minor damage to the basic aircraft structure resulted from the crash and that the occupiable area of the aircraft,

with the exception of the seats and restraining devices, was almost completely intact.

As a result of the findings, it was recommended: (1) that immediate steps be taken toward increasing the integrity of both cockpit and cabin seats and

(2) that consideration be given to attachment of all restraining devices to the basic structure of the aircraft.

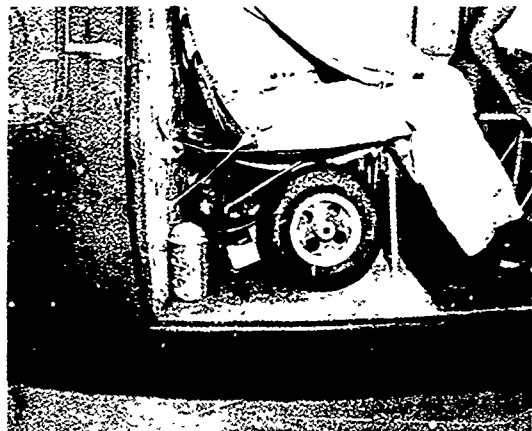
From this point the aircraft settled in a tail low attitude until striking the ground. During this latter sequence, the cabin area just aft of the pilot's seat on the right side was impaled on a stump approximately 10 inches high which penetrated into the inhabitable area.

The investigation conducted on 22-24 August 1960 revealed that the predominant causes of injuries were failures of the seat anchorages and partial collapse of the aft bulkhead supports. A contributing factor was loose gear stowed under the troop seats.

The investigation also found that the occupiable area of the aircraft received extensive damage due to the partial collapse of the aft bulkhead supports, cabin roof, and complete collapse of the side supports.

1. Immediate steps be taken toward increasing the integrity of both cabin structure and seats;

2. Adequate restraining devices be employed for all loose equipment that must be carried or to eliminate the carrying of potential injury producing items in the aircraft.

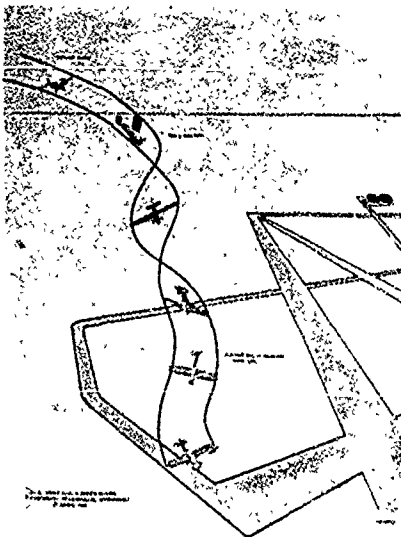
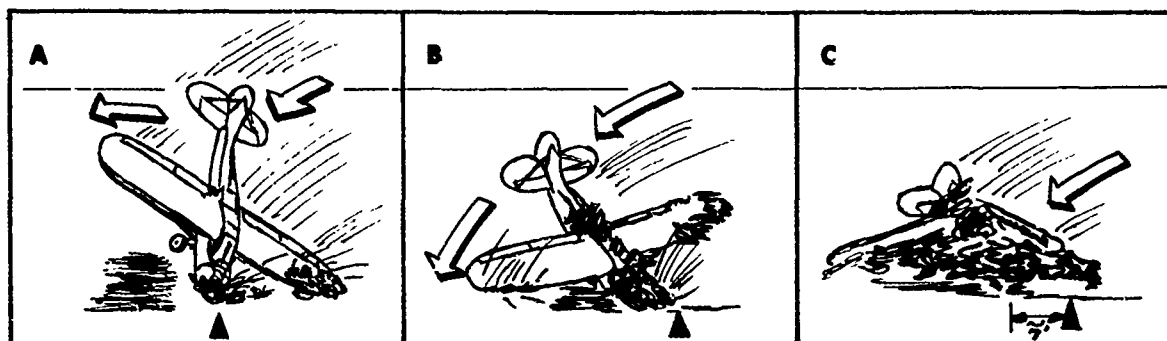
The aircraft was examined at the crash site on 29-30 April 1960. Photographs of the wreckage and of essential components and equipment were made during the course of the investigation. There were no witnesses to the accident; however, gouges in the ground and aircraft damage details, together with a graphic plotting of wreckage distribution, made it possible to reconstruct the kinematics of the crash sequence - basically a low altitude stall-spin. Estimation of the flight path angle, velocity, impact conditions, stopping

In view of both crash force magnitude and direction, as well as the extent of aircraft damage, this accident was considered non-survivable.

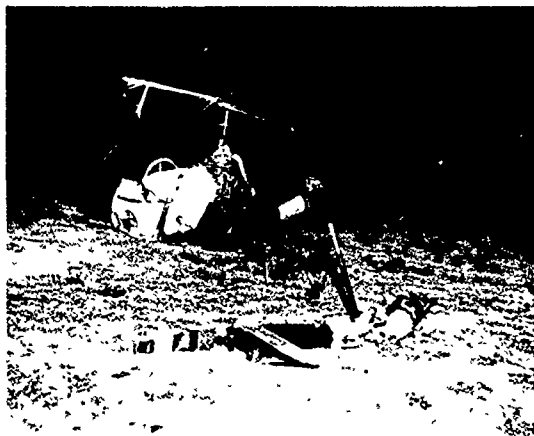
U. S. ARMY NATIONAL GUARD H-23C HILLER HELICOPTER ACCIDENT PHOENIX, ARIZONA 8 DECEMBER 1960

A U. S. Army National Guard H-23C Hiller helicopter was inadvertently flown into the ground while the pilot was in the process of selecting a suitable area to practice night landings; it crashed at approximately 2010 hours, 8 December 1960, in northeast Phoenix, Arizona.

With position and landing lights on, the aircraft struck the ground slightly nose-down in a gentle left turn at 50 to 60 knots forward velocity. The left skid hit first, followed by the left front underside of the cockpit. The rotors appeared to have flexed down into the tail boom, shattering the blades and tearing the tail boom into two main sections.

Investigation conducted on 8-9 December 1960 indicated that the latch on the safety belt did not hold throughout the crash sequence, for reasons still undetermined. During the initial impact, the belt held just long enough to allow the pilot to flex forward, at which point the buckle opened, allowing the pilot to go head down, backwards, through the upper portion of the bubble out of the aircraft.

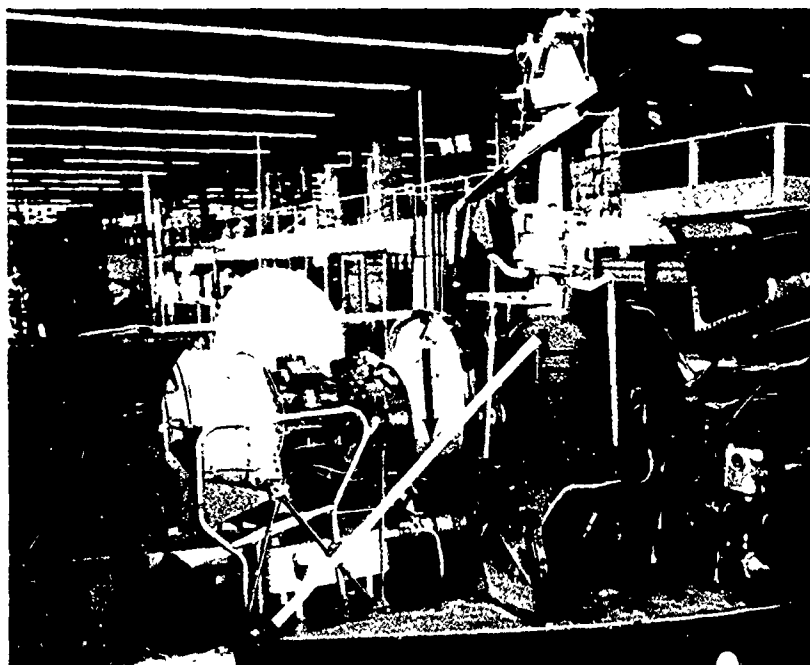
The first evaluation by AvCIR on 15-16 November 1955 cited many specific hazards relating to litter installations, troop seats, crew seats, safety belt installations, and similar items. Perhaps the most significant item cited, however, was the strength of mounting the transmission. For this the following comment was made:

"It appears that crash loads will cause the transmission unit to break free and pass downward through the cabin bulkhead into the cabin, thereby crushing the occupants."

A suggestion of a tension tie (cable or tube), as illustrated below, was made.

During the second evaluation by USABAAR, many of the same points were made with specific mention of the failure of the transmission mount in the wrecked YH-40. There also was transmission

failure in all five (5) accident cases with the transmission going into the cabin area with serious results in one of the accidents.

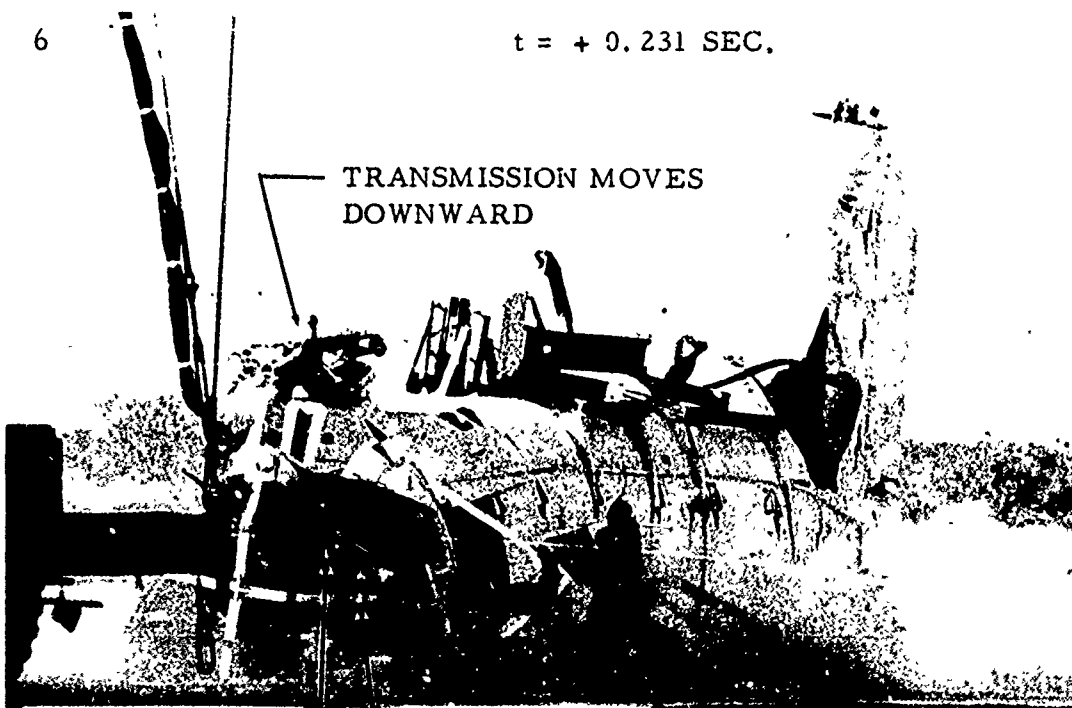
$t = + 0.231 \text{ SEC.}$

TRANSMISSION MOVES
DOWNWARD

PILOT'S ELBOW - PILOT'S HAND

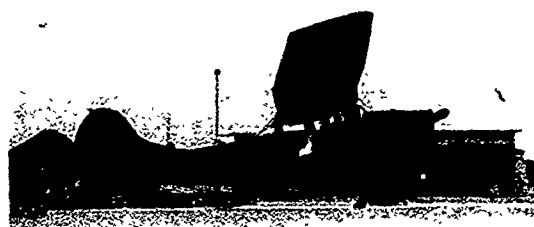
- (1) The aircraft would be suspended from an H-21 helicopter. A special sling which provided excellent stability was designed and fabricated by AvCIR. The helicopter was provided by Fort Huachuca.

- (2) The aircraft was to be dropped from a height of 60 feet at a forward flight speed of 35 knots. This was to simulate a straight ahead stall condition

with an attempt to recover at low altitude. The actual drop was made at 35 knots, but the altitude was approximately 40 feet instead of 60 feet above the terrain.

- (3) Impact was to be on a relatively level terrain with the impact angle being 30 degrees nose down with no roll or yaw. Due to the low altitude at actual drop (40 feet) and a slightly

premature release, the aircraft impacted against the side of a ravine just ahead of the level terrain selected for the impact area.

This made an impact angle of 60 degrees with reference to the terrain (aircraft nose down 30 degrees and impact slope 30 degrees).

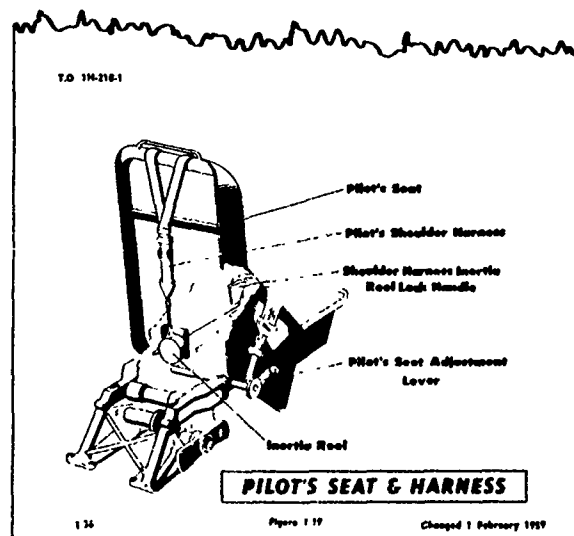
During an investigation of an accident involving an H-21 helicopter in which one crew member in the cockpit was fatally injured, it was noticed that the safety belt was improperly positioned on both seats.

In the medical report of this accident, and in one other H-21 accident on file at AvCIR, the medical investigators called attention to positioning of the safety belts as being a probable source of rib-cage and internal injuries.

The AvCIR accident investigation, plus the medical doctors' comments, led to an examination of the Technical Manual covering the safety belt installation. It was found that a 15 November 1957 revision carried a caution note on the proper installation of the belts and a subsequent revision (1 February 1959) deleted the caution note and illustrated

an improper installation.

The preceding information was presented in a Crash Injury Prevention Bulletin with a recommendation that the discrepancy be brought to the attention of all units utilizing H-21 helicopters and that the Technical Manual be revised to eliminate the discrepancy.

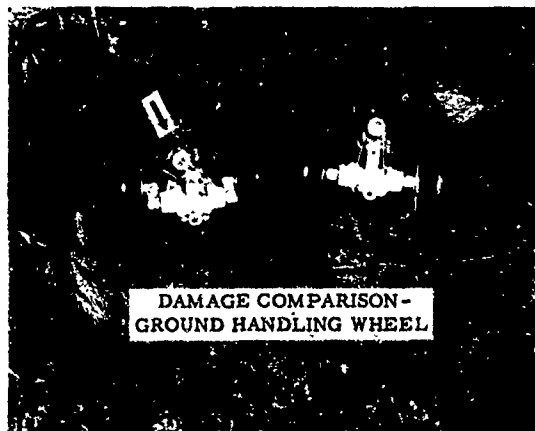
Part II of the bulletin discussed and illustrated the manner in which certain items of loose equipment were stored under the troop seat during operation of the aircraft.

This information resulted from the investigation of an accident in

which one occupant of the troop seat was seriously injured when the troop

seat failed and the occupant bottomed out on a set of ground handling wheels stowed beneath his seat.

It was recommended that the area beneath the troop seats be kept free of loose equipment, and if non-rigid equipment is stored underneath the

seat that it be securely anchored to prevent its being thrown through the aircraft in the event of an accident.
